Internal Metallic Pipe Coatings for the Geothermal Industry

Idaho National Engineering & Environmental Laboratory

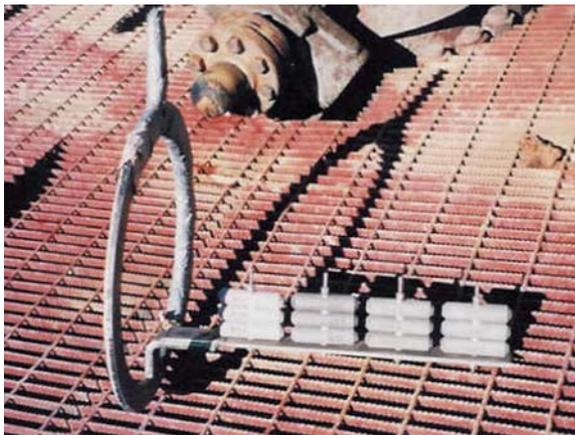
Figure 1. Corrosion Coupon Tree

The initial testing utilized a corrosion coupon tree for inserting test coupons into operating systems. The coupons and coupon tree were fabricated at Flame Spray Industries under the direction of Zatorski Coating Company(ZCC). The coupon tree and the four sets of coupons are shown in Figure 1. The coupon tree was installed at CalEnergy’s Salton Sea facilities in December 2001 (Figure 2). The initial coating materials selected for the CalEnergy coupon test (Table 2) were all known to perform well in environments with similar pH, temperature and pressure.^{1, 2, 3} There were 3 coupons each of Ultimet, IN625, Hastelloy C276, and 4777. The samples were 1.0 inches in diameter and 4.0 inches long with tapered ends. The coupons had a

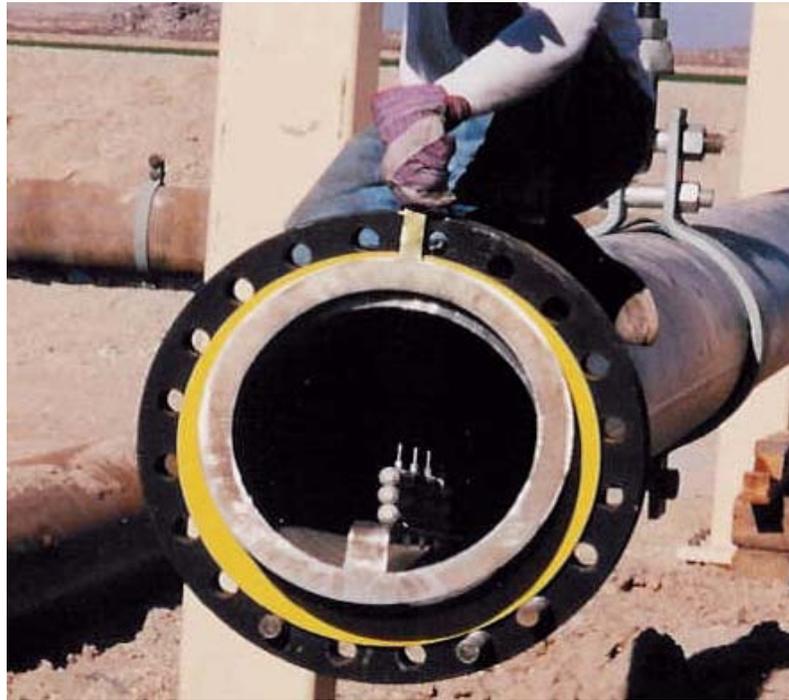
Figure 2 Insertion of the coupon tree in VON-4 pipeline, Salton Sea

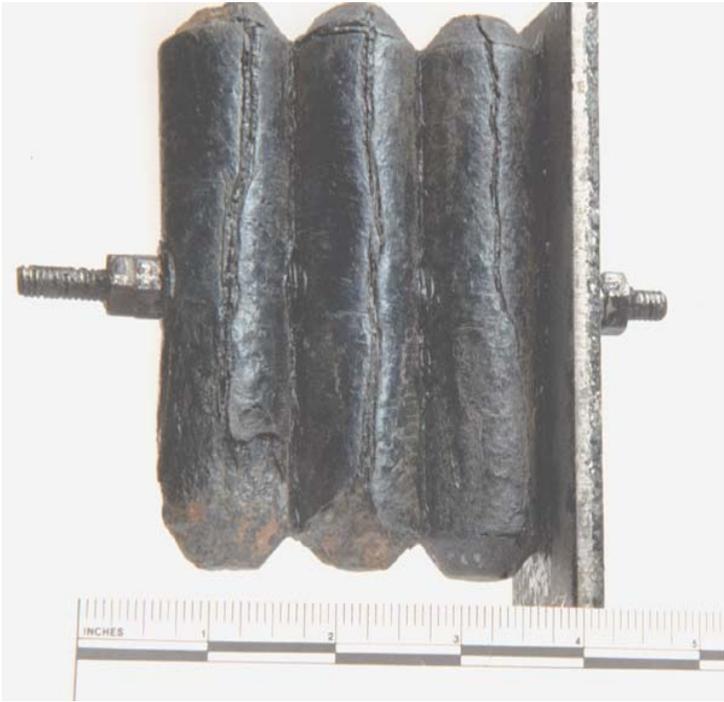
Figure 4 Ultimet coupons after 1200 hours

The Ultimet coupons are shown after exposure in Figure 4. There was a hard, tightly adherent surface deposit on the Ultimet coupons and the corrosion coupon tree. This scale was analyzed and was found to be silicate based with every other element of the liquid phase shown in Table 1 being present. The deposit was thicker on the corrosion coupons than on the C-276 plate material of the corrosion tree. One possible explanation for this is the coupon tree material has a better initial surface finish than the corrosion coupons, which may affect the scale deposition rate.
